**Preliminary Geotechnical Investigation  
Proposed Residential Subdivision Development  
Lot 11 DP 534539 No 215 Macarthur Road  
Spring Farm, NSW**

Prepared for  
**Crownland Developments  
Suite 502, Level 5, 95 Pitt Street  
SYDNEY NSW 2000**

**Ref: JC25487B-r1  
May 2025**

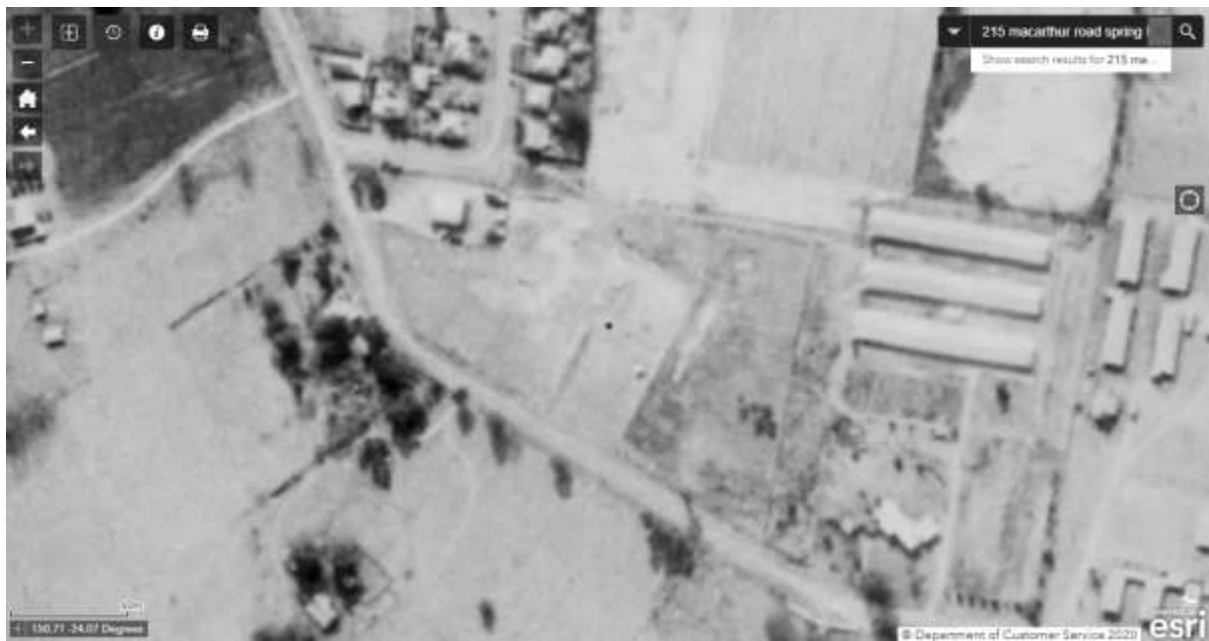
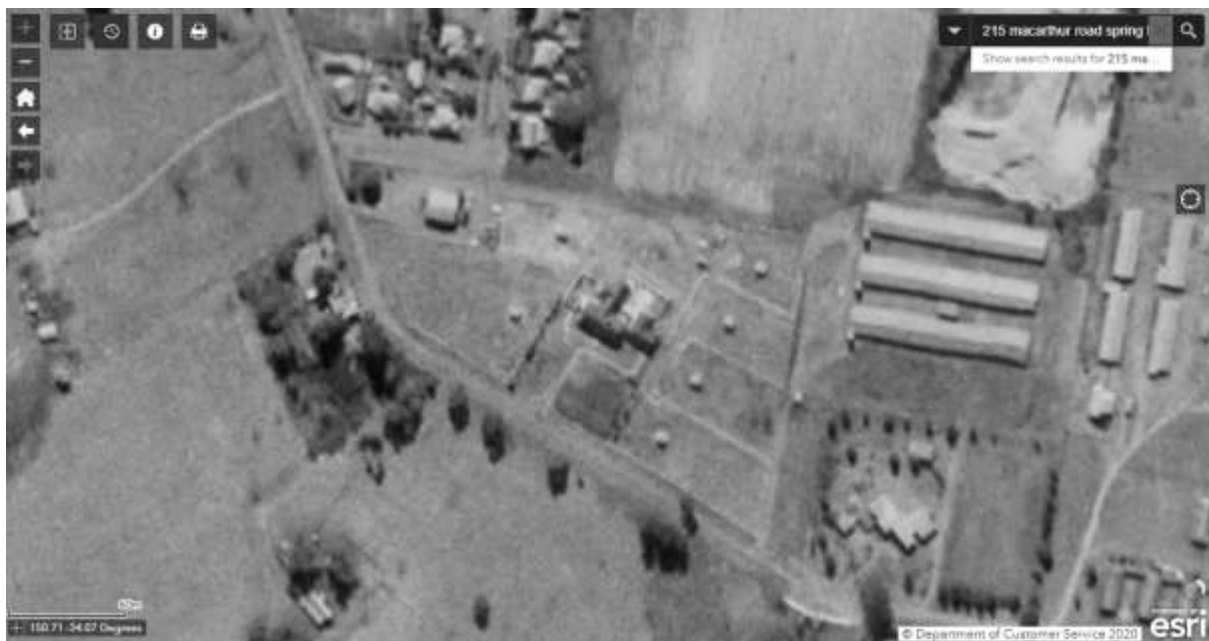
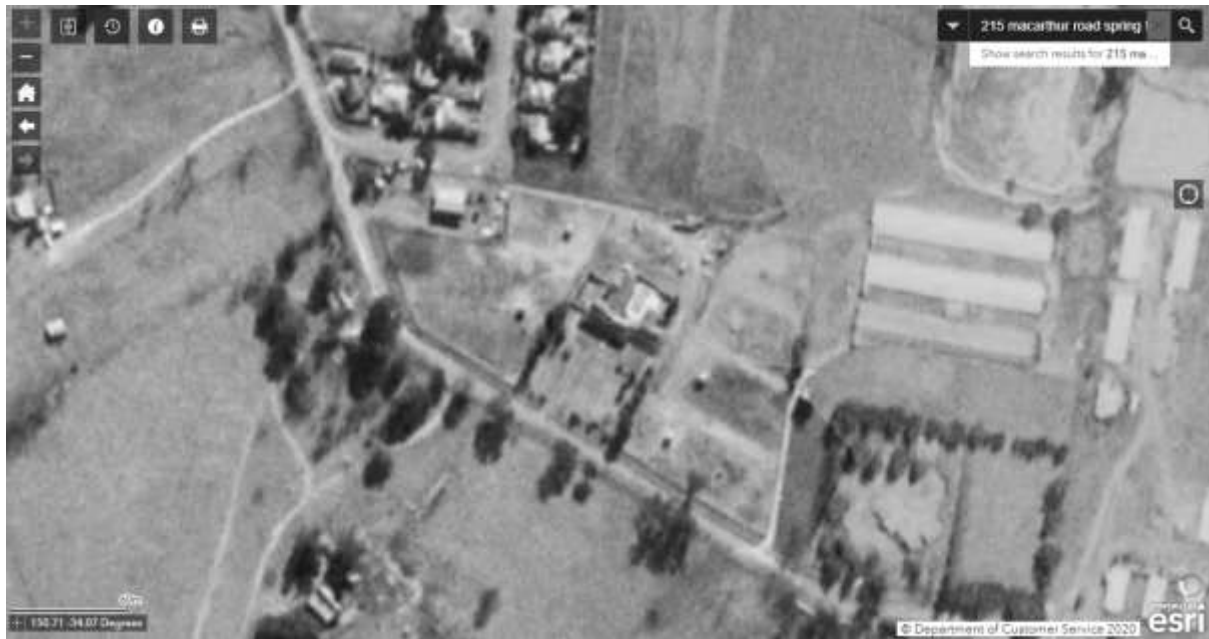
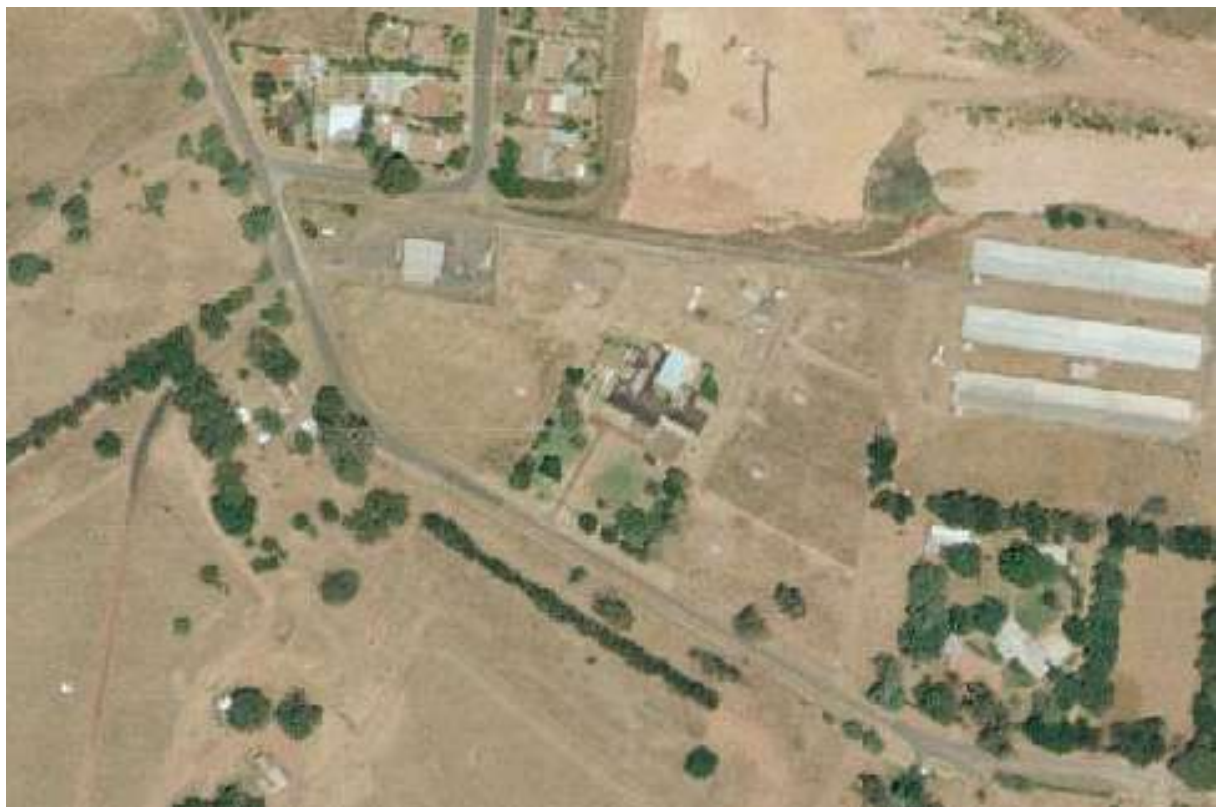
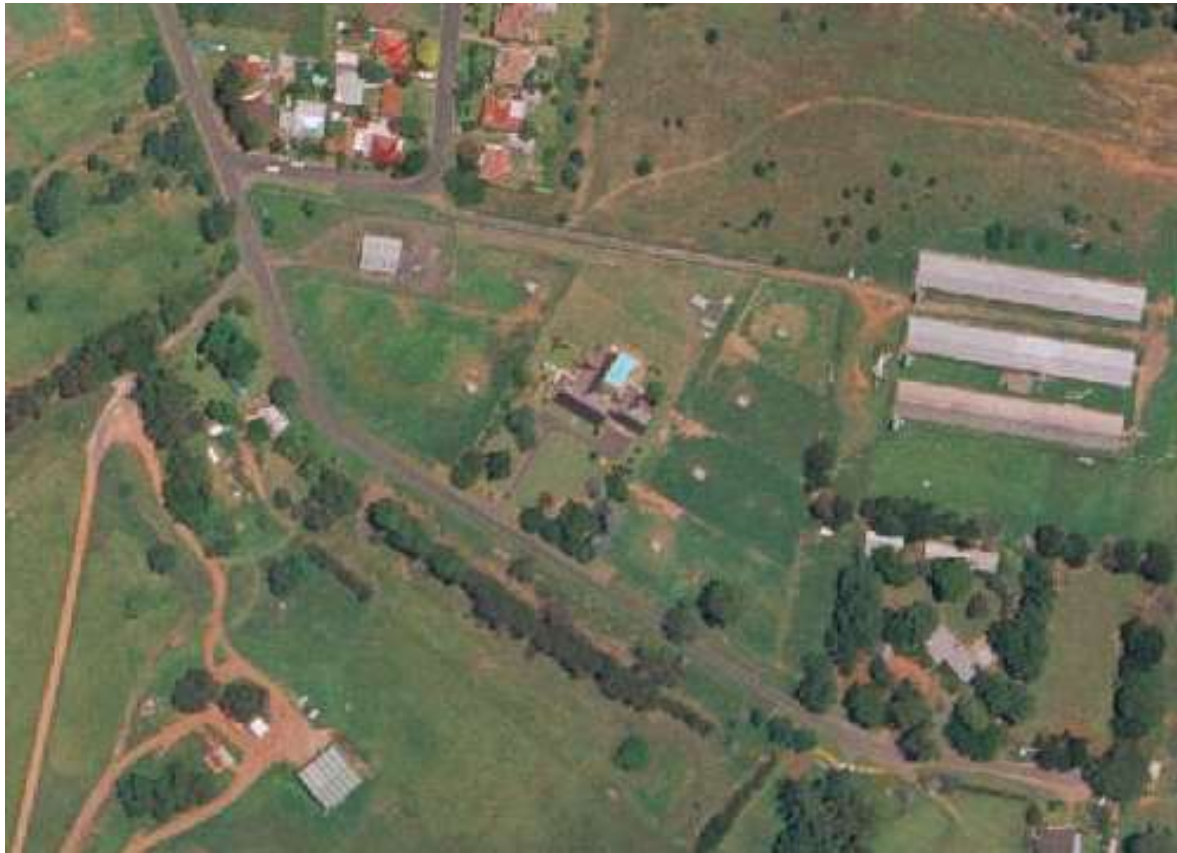
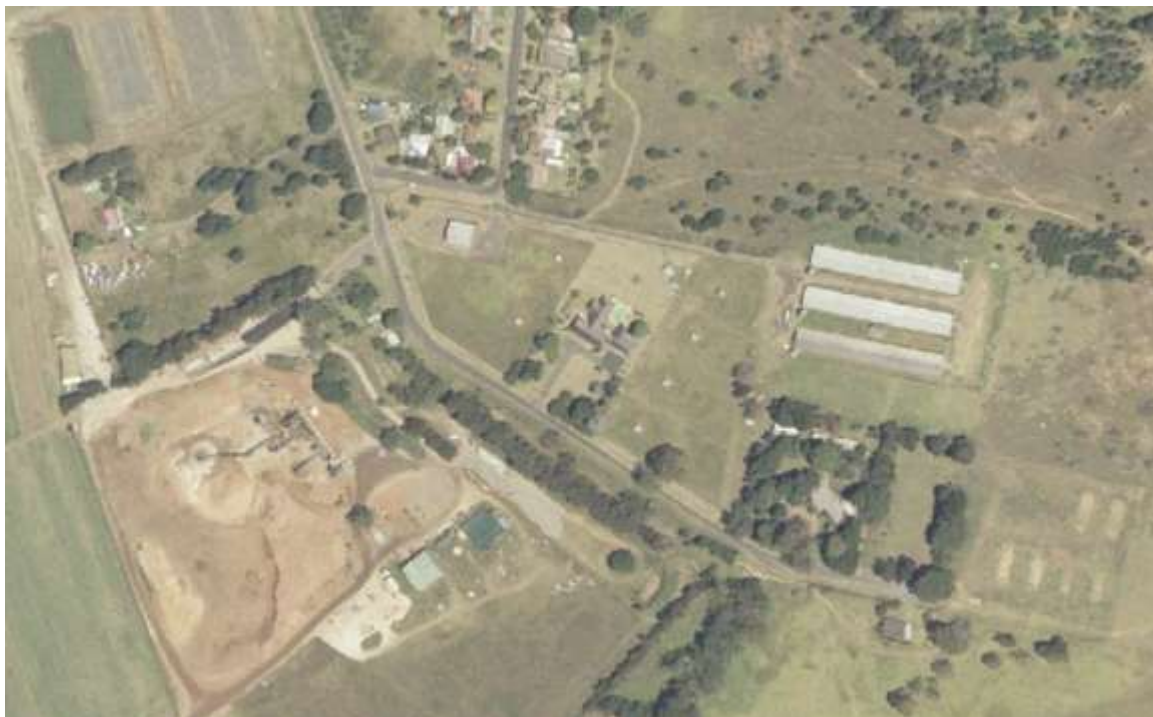
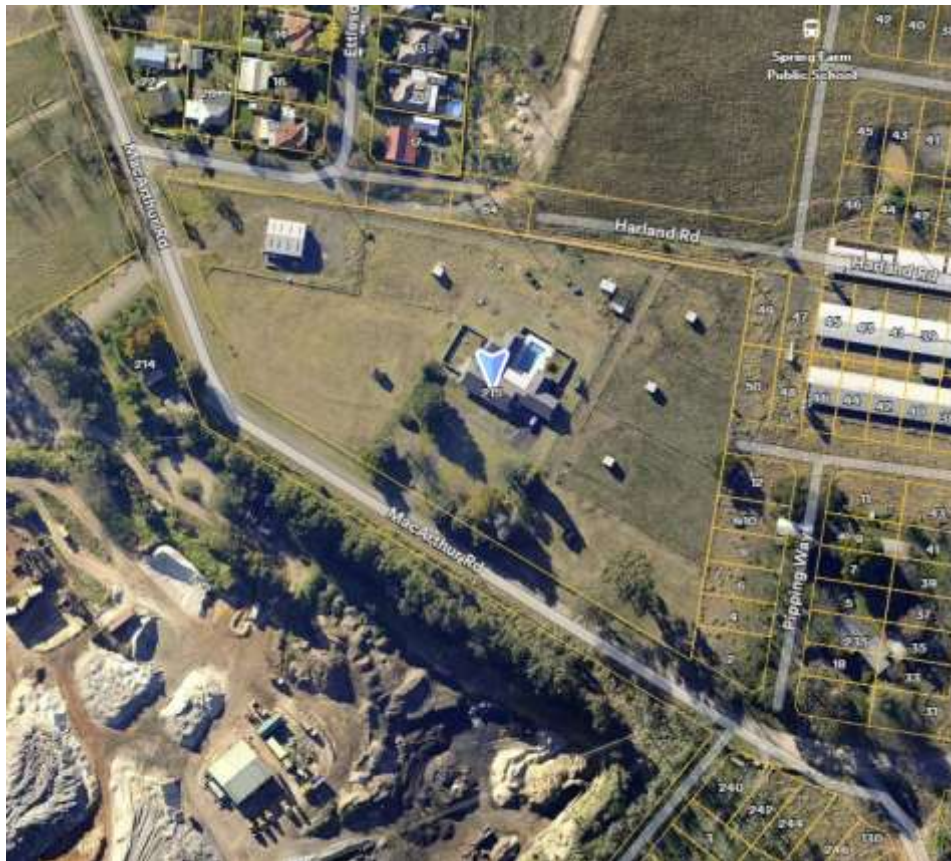
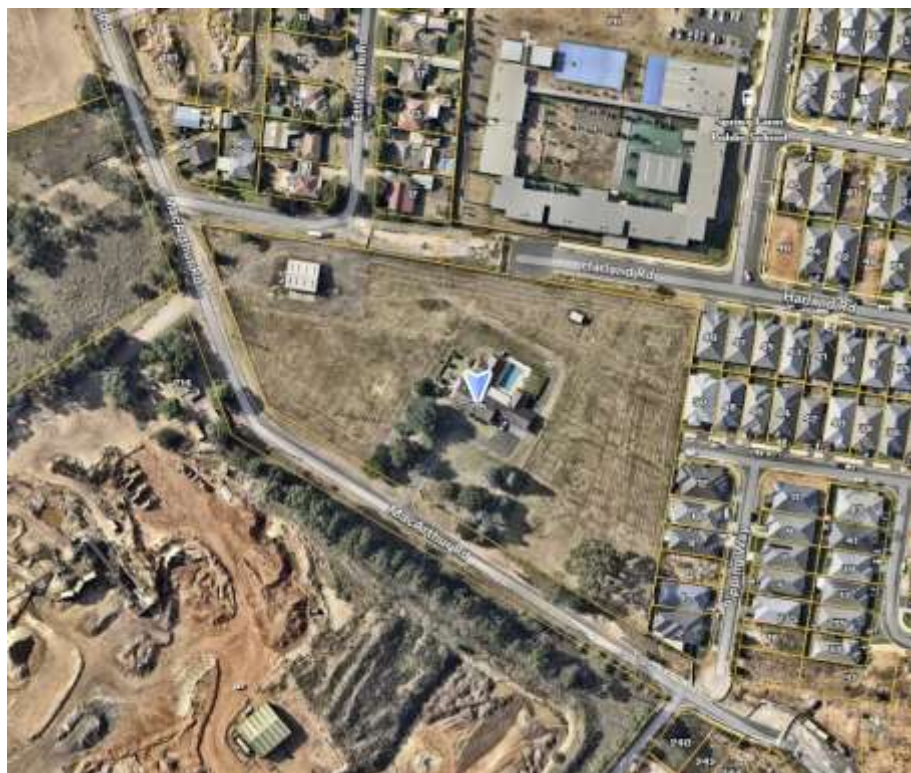
### Historical Photographs

- The historical aerial photographs indicate the site to have remained undisturbed since the 1960's with no ground modification by excavation and filling from human activities such as sand extraction/mining, dredging, dam construction and land filling. On this basis, there is a high level of confidence that the insitu foundation material is predominantly in its natural state and homogeneous with no unexpected relict rubbish or compressible burial ground.
